# **Debris/Ice/TPS Assessment and Integrated Photographic Analysis of Shuttle Mission STS-83**

*Process Engineering/Mechanical System Division/ET-SRB Branch,  
Kennedy Space Center, Florida*

**DEBRIS/ICE/TPS ASSESSMENT  
AND  
INTEGRATED PHOTOGRAPHIC ANALYSIS  
OF  
SHUTTLE MISSION STS-83**

**4 April 1997**

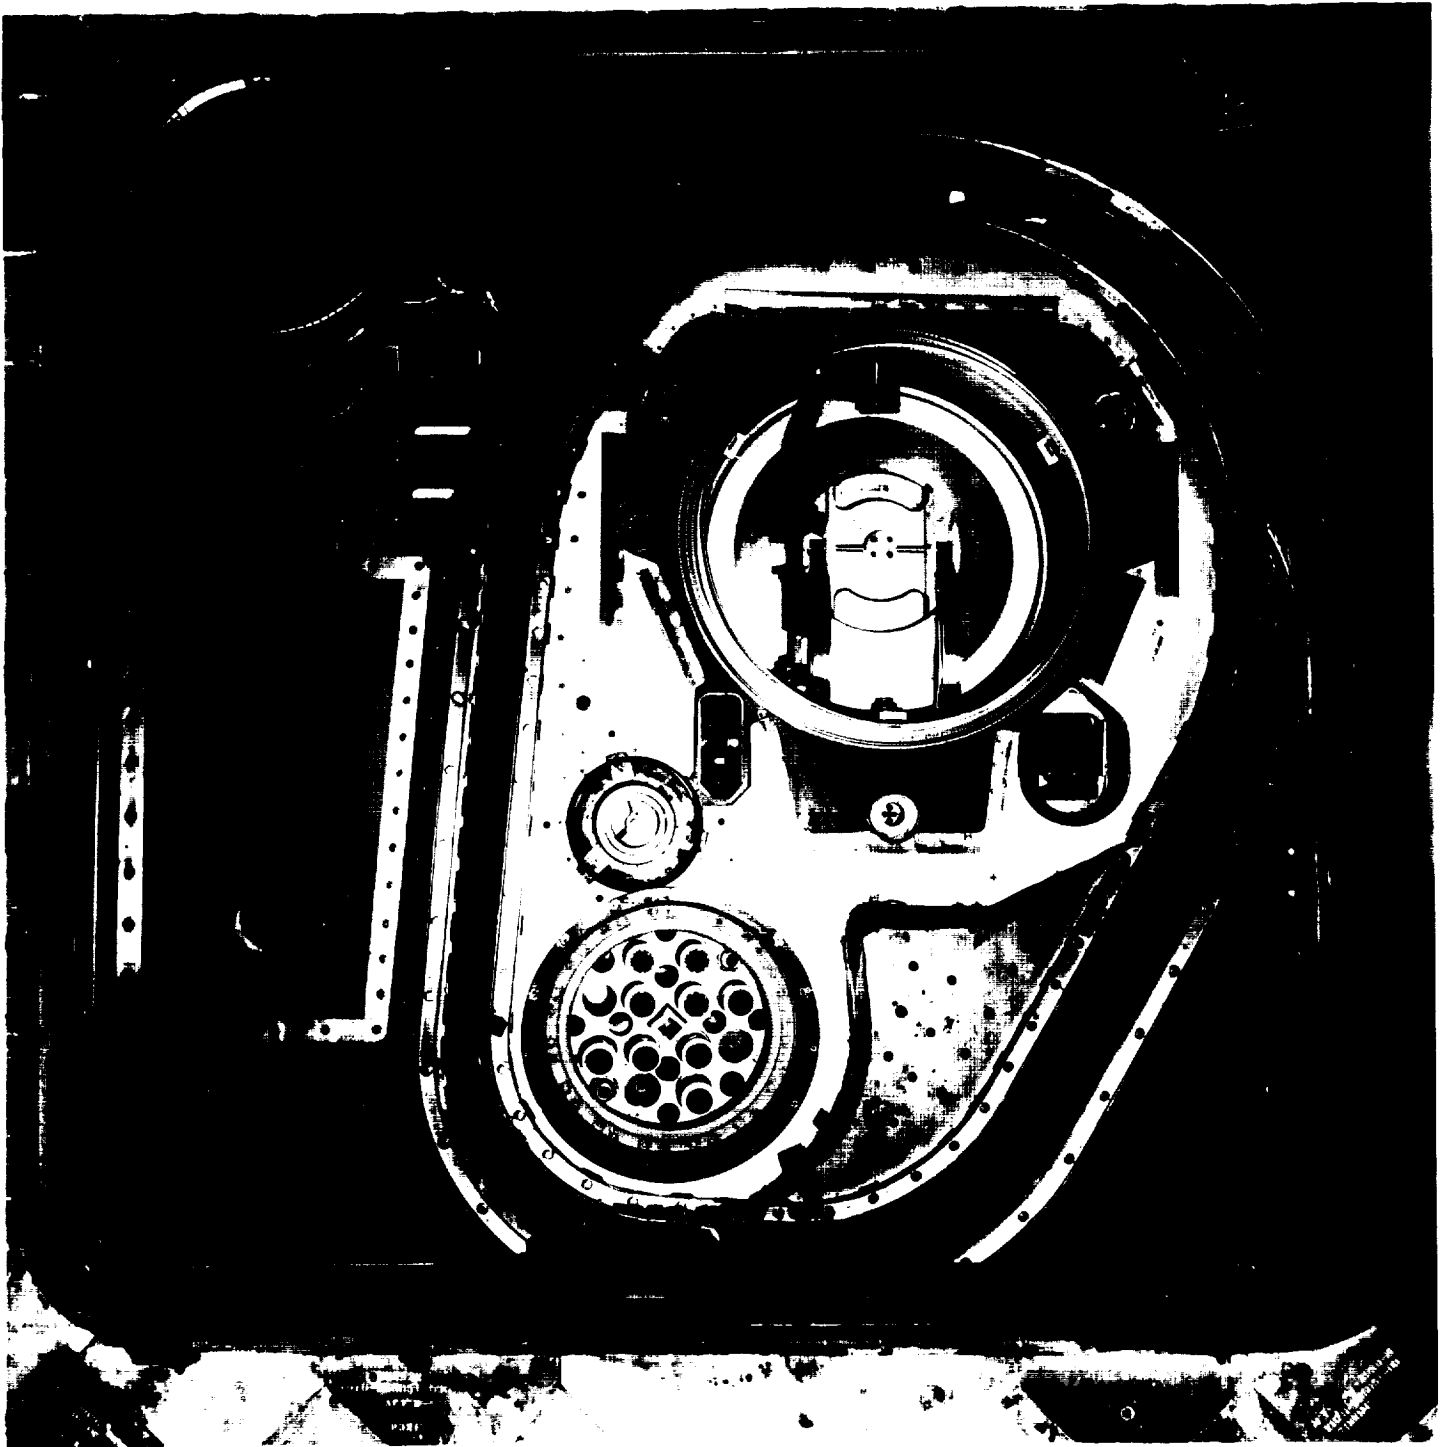
Photo 24: LO2 ET/ORB Umbilical

Bent metal, approximately 1-inch in length by 1/4-inch wide, was visible on the trailing edge of a spacer between two bolt heads on the inside surface of the LO2 ET door near the forward outboard corner. This same condition has occurred after the last three flights on different Orbiters.

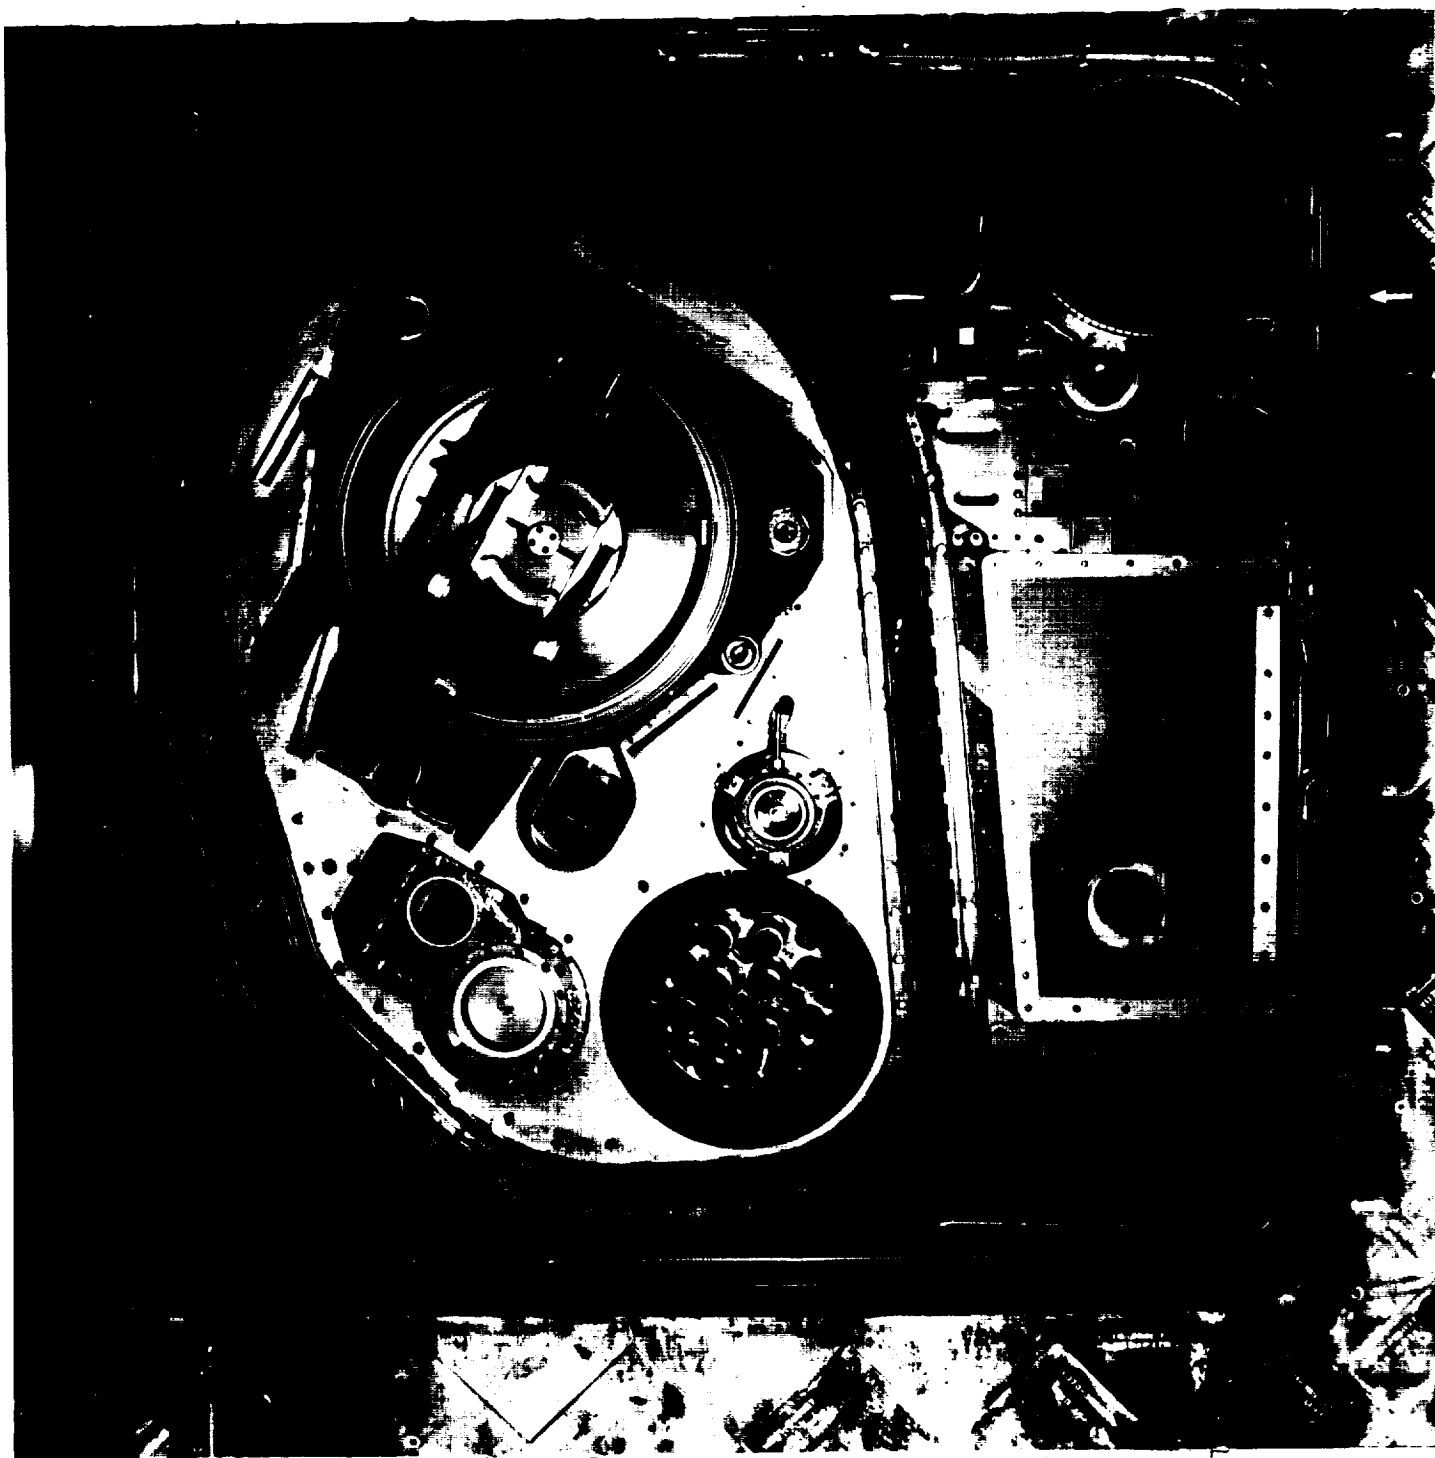
Photo 25: LH2 ET/ORB Umbilical

The LH2 ET/ORB umbilical appeared to be in good condition after separation with no TPS damage. Frozen hydrogen adhered to the 17-inch disconnect and parts of the separation interface. The fire barrier on the outboard side of the LH2 umbilical exhibited two unusually large bubbles that were estimated to be 3" x 2" and 6" x 2", respectively. Typically, foam had eroded from the horizontal (clamshell) section of the cable tray

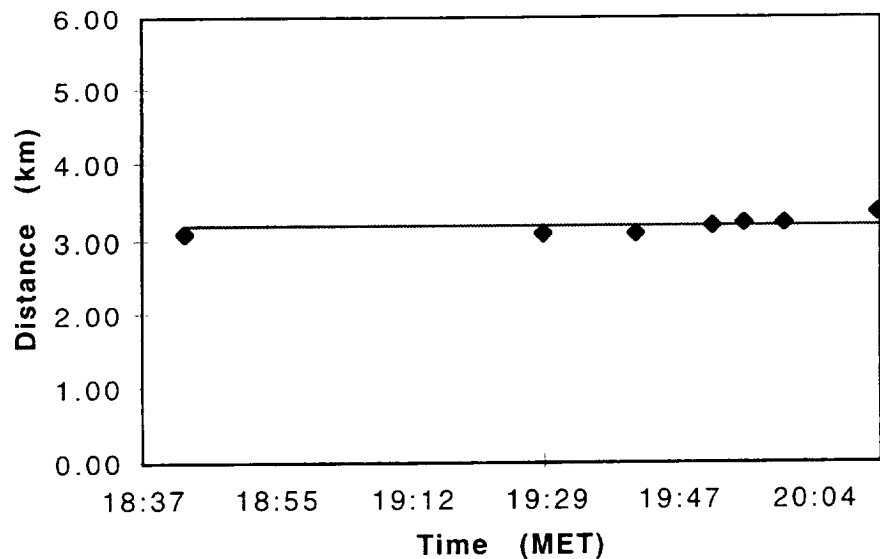
Figure 2.5.2 ET Separation Velocity

The distance of the external tank was calculated on eight frames. On the first usable view, the external tank was calculated to be a distance of 3.1 km away from the Orbiter at 18:43 MET. On the last view, the tank was calculated to be at a distance of 3.4 km (1.5 minutes after the first view). The tank separation average velocity was determined to be 3.5 meters/second (m/s), with an uncertainty of approximately 1 m/s. The tank tumble rate was approximately 0.5 degrees/second and the roll rate was approximately 0.6 degrees/second.

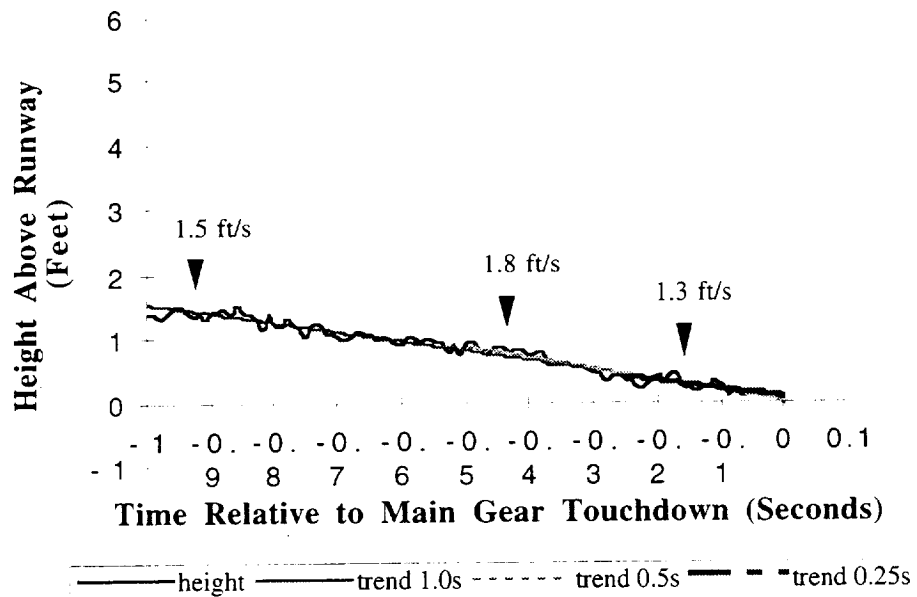
Figure 2.6.1 (A) Main Gear Height versus Time Prior to Touchdown

The measured main gear sink rate values were found to be below the maximum allowable values of 9.6 ft/sec for a 211,000 lb. vehicle and 6.0 ft/sec for a 240,000 lb. vehicle (the landing weight of the STS-83 Orbiter was reported to be 235,286 lbs.). The sink rate measurements for STS-83 are given in Table 2.6.1. In Figure 2.6.1(A), and 2.6.1(B), the trend of the measured data points for the image data is illustrated.
